**NAVAL WEAPONS
STATION
CHARLESTON
FLEET MOORINGS
UNDERWATER
INSPECTION
REPORT**

AUGUST 1983

OCEAN ENGINEERING
AND CONSTRUCTION PROJECT OFFICE
CHESAPEAKE DIVISION
NAVAL FACILITIES ENGINEERING COMMAND
WASHINGTON, D.C. 20374

FPO-1-83 (17)

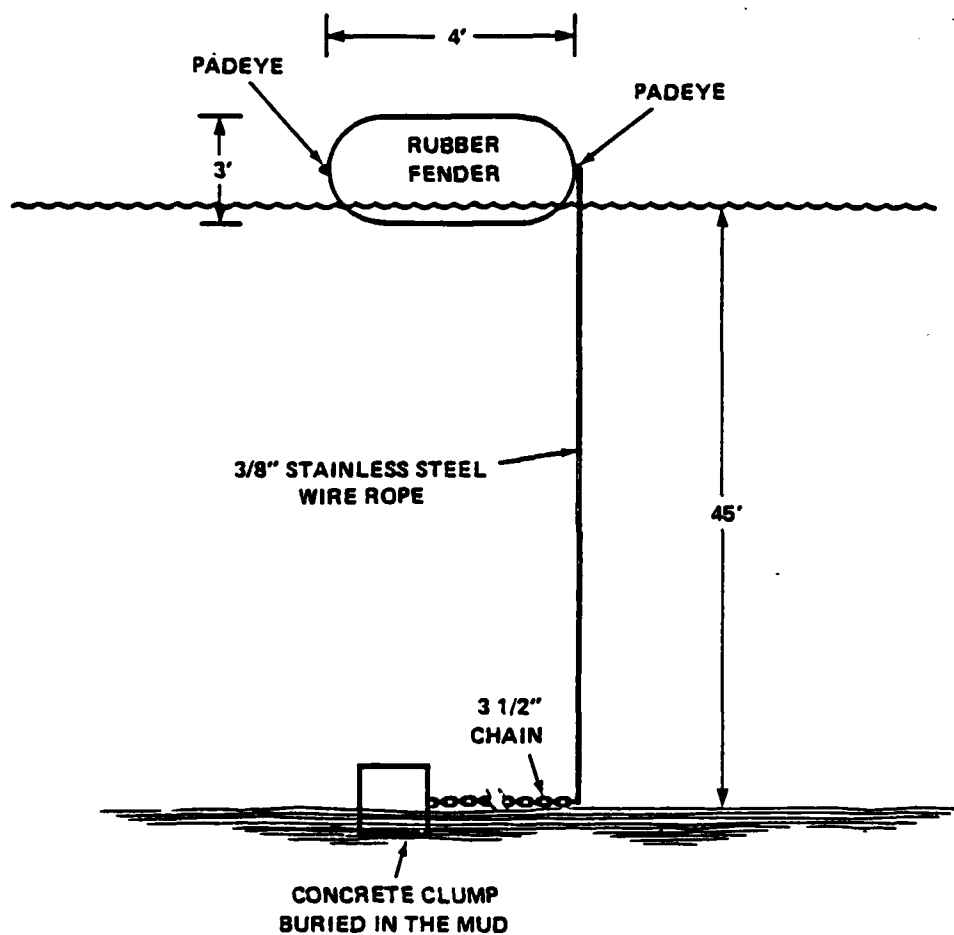
Figure A-1. Mediterranean Mooring Bow Leg Marker Buoy

Currently, large rubber fenders (normally used for protection of yard craft) are being used in place of buoys. The buoys are located about halfway between each stakepile and the Tender (see Figures 1 and 2), and are used as navigation aids during Tender mooring operations. Each marker buoy is attached by 3/8-inch steel wire rope to a short length of 3 1/2-inch chain which is embedded in a concrete clump (see Figure A-1). Note: The marker buoys (including riser and anchor) are used only as navigation aids and do not serve as in-line mooring components.

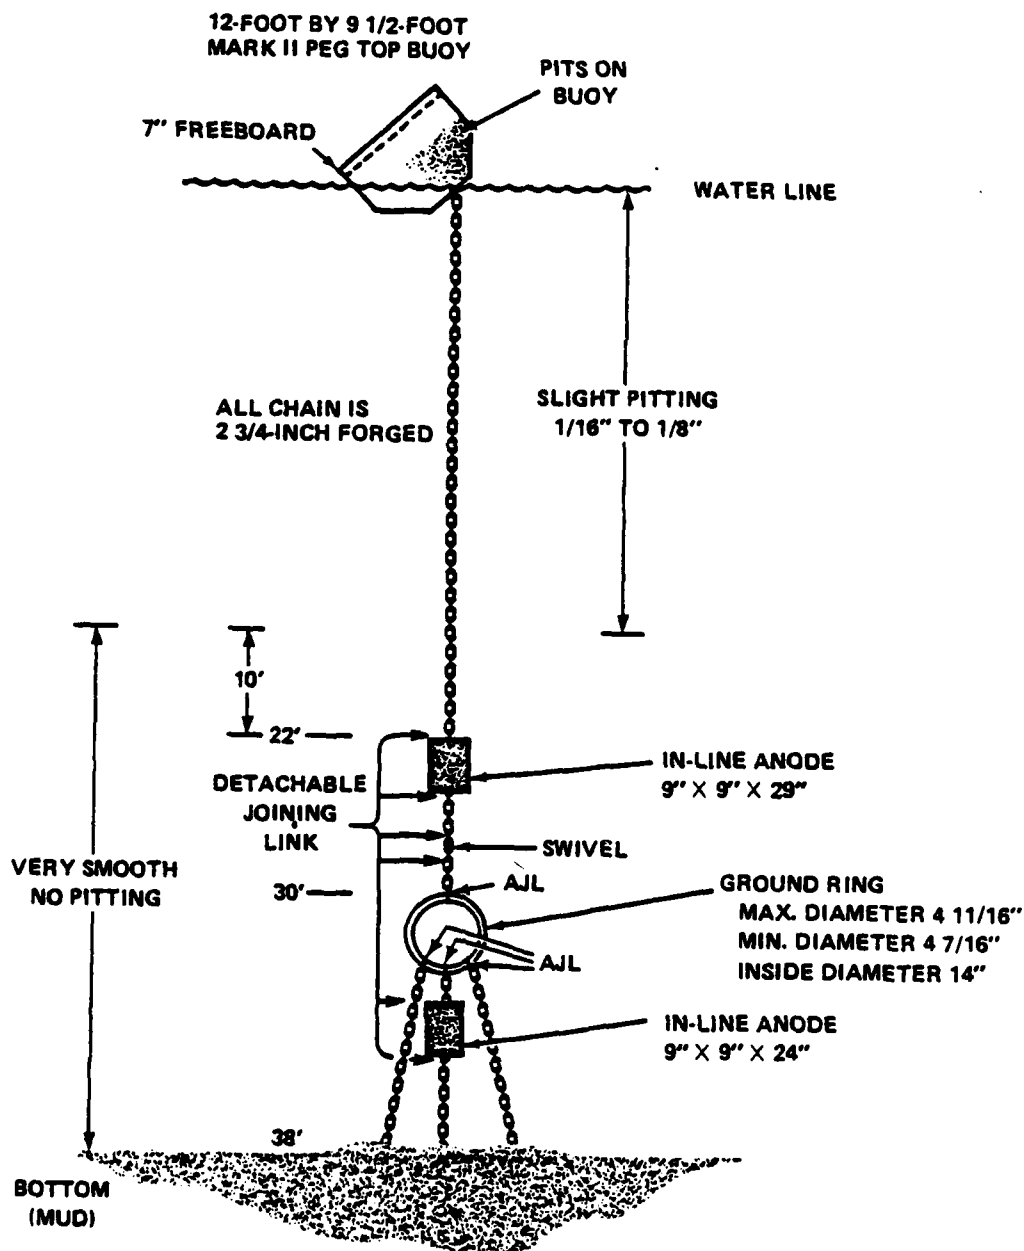
Figure A-2. Auxiliary Mooring

This Mark II Peg-Top buoy with hawse pipe measures 12-feet wide by 9 1/2-feet high. The buoy has a 45° list which could be caused by failure of its watertight integrity. It has two wooden fenders which are covered with thin steel strips and a 1/4-inch-thick steel plate covering the topside. The buoy is badly rusted and layers of rust are flaking off. In addition, the buoy has 1/8-inch-deep pitting in its bottom, and the top has a heavy coating of guano. In general, this buoy is in poor condition.

The wire diameter of the riser chain is 2 3/4-inches, and double link measurements showed that the chain is greater than 90 percent of its original wire diameter. An in-line anode, measuring 9 by 9 by 29 inches, was found in the riser about 22 feet below the surface, and a swivel was noted just below the anode. The riser chain is in good condition.

The ground ring is about 30 feet below the surface and its minimum wire diameter was measured to be 4 7/16-inches. The ring is in good condition.

About 8 feet below the ground ring (at a depth of 38 feet) the three ground legs drop vertically into the bottom. Each of the ground legs is comprised of 2-3/4 inch forged chain, and measurements of these legs were all above 90 percent of original wire size. Just below the ground ring, one of these legs has a zinc anode which measured 9 by 9 by 24 inches. Figure A-2 is a schematic drawing of the Auxiliary Mooring.

The buoy should be removed from the water and the cause of its list determined and repaired. The buoy should also be completely overhauled. The remainder of the mooring is in good condition.

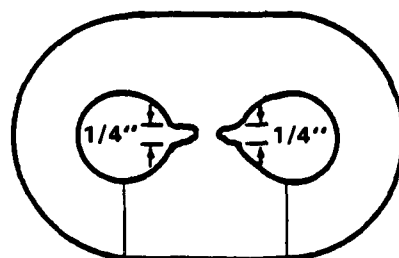
Figure A-3. Deep Cuts on Either Side of Detachable Link Stud

- Ground leg K has a badly worn or damaged detachable link at the 45-foot depth.
- The anchor joining link at the inboard end of leg J is missing the lead plug which secures the pin in place.

Ground Leg K. This leg is 2 3/4-inch cast chain which drops vertically into the bottom. Detachable links were found at 20- and 45-foot depths. The detachable link at the 45-foot depth is damaged and should be replaced. There appears to be a deep 1/4-inch-wide cut into each side of the stud of this link (see Figure A-3). Double link measurements near the mudline were between 80 and 90 percent. The chain is heavily rusted and no evidence of pitting was noted. The leg has no catenary.

LEG K

- The damaged detachable link in ground leg K should be replaced.
- A lead plug should be inserted in the anchor joining link at the inboard end of leg J.

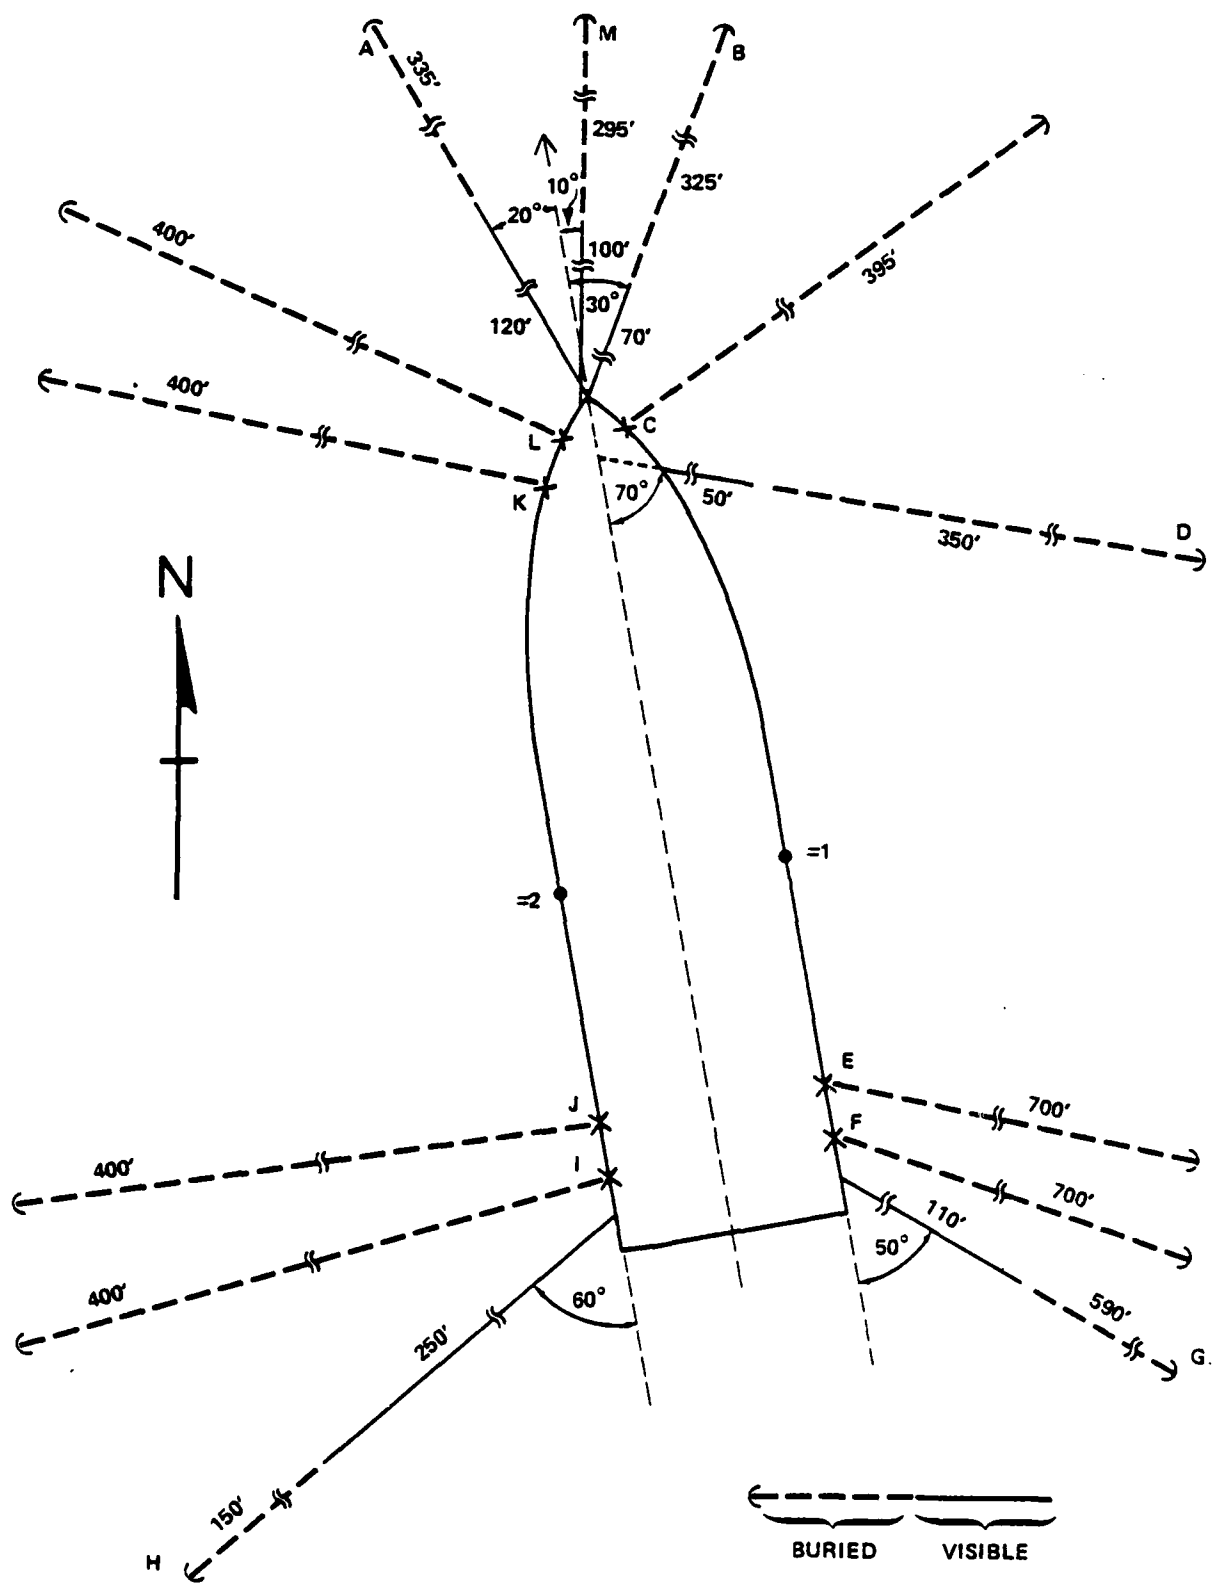
Figure A-4. ARDM Leg Positions

Except for some heavy pitting and rusting, the chain appears to be in fair to good condition. However, only six legs are under tension. The remaining seven are slack and drop vertically into the bottom. Figure A-4 shows which legs are under tension, while Table A-1 provides a summation of the condition of the ARDM-2 ground legs.

The ARDM-2, USS ALAMAGORDO, has an impressed current system consisting of port and starboard direct current power supplies. The starboard power supply puts out more amperage than the port side. This could be the reason for heavy localized corrosion of the starboard leg chains. However, because the condition of the chain in each leg was not recorded when the chain was installed, it is impossible to draw any firm conclusions regarding the possible corrosive effects of the imbalanced power supplies. Numbers 1 and 2 in Figure A-4, show the positions of the starboard and port impressed current power supplies.

- The drydock should be realigned to the designed heading, and each of the 13 legs should be reset and pretensioned to provide the proper chain catenaries.

- The drydock should be realigned to the desired magnetic heading and each of the ground legs should be reinstalled so that all are under tension and sharing the mooring loads.
- The impressed current system should be inspected, repaired, and calibrated as required to ensure that the potentials being provided are within design limits.
- The damaged detachable link in leg K should be replaced.
- The lead plug should be replaced in the anchor joining link which connects leg J to the drydock.
